## SHORELINE PROTECTION OF HISTORIC AND COASTAL RESOURCES AT BRUNSWICK TOWN/ FORT ANDERSON

### ABSTRACT

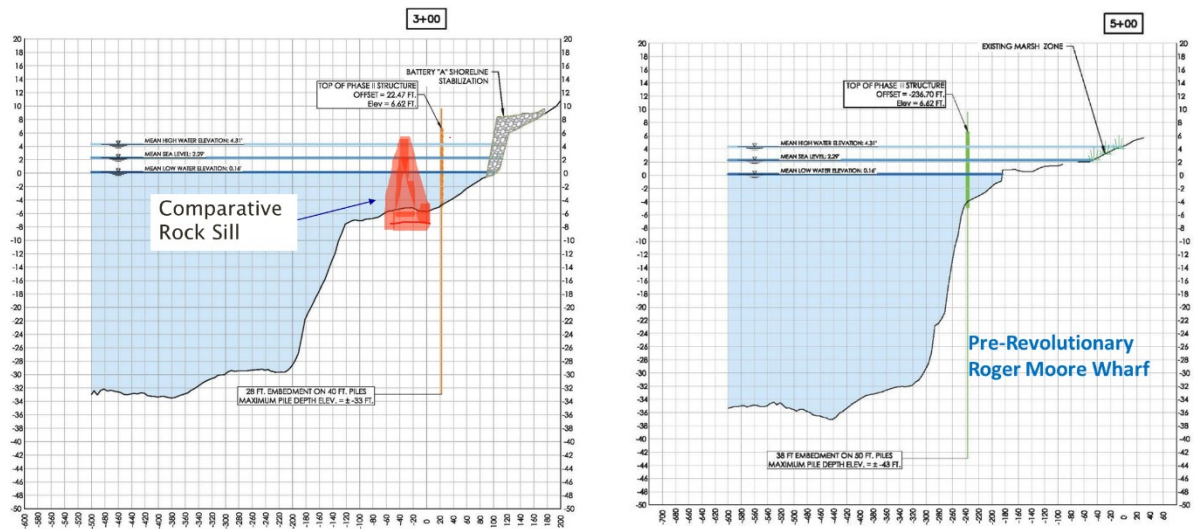
**Figure 5. Cross Section 3+00 and 5+00 noting horizontally limited areas for rock sill & natural wharf.**

This type of shoreline protection would have worked along the Battery A shoreline, but there was not sufficient horizontal area to accommodate such a large rock breakwater at the historic wharfs where the original, natural river channel occurred (see Figure 4 and 5). At the wharfs, the river has a natural drop off, and the installation of a rock sill would have covered the coastal resources which DNCR sought to also save.

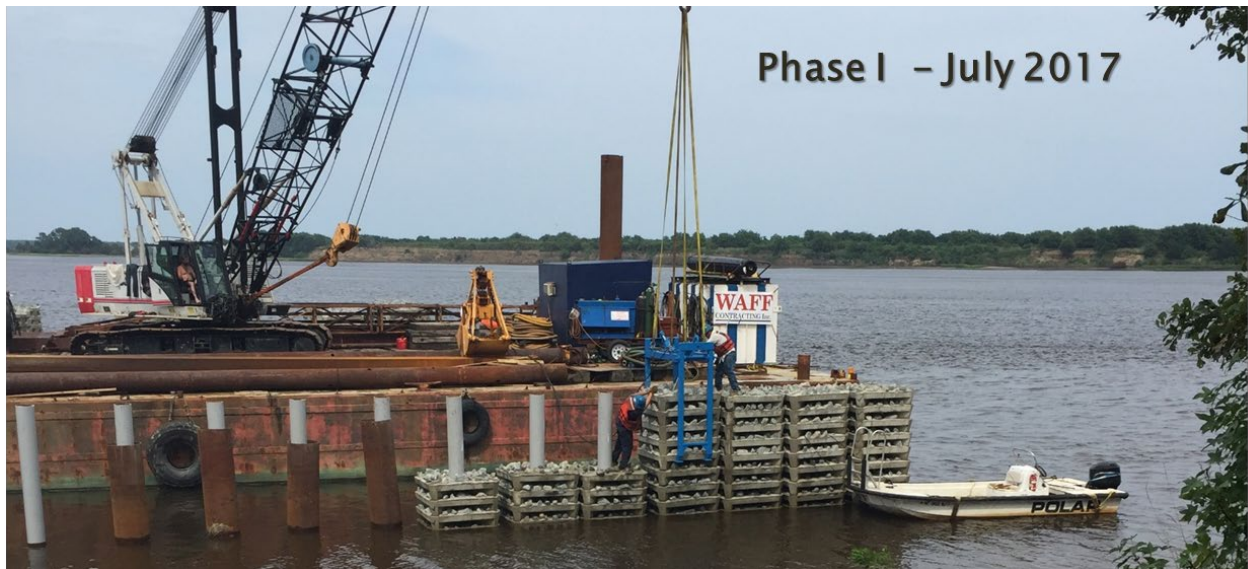
**Figure 8. Phase 1 installation with ecodisks stacked to 2' above mean highest high tide.**

The initial Phase 1 structure was installed with extra ecodisks. These disks were installed to the noted height, originally set to 2 feet above mean highest high tide, with the understanding that these extra ecodisks would be removed and repurposed for Phase 2. Therefore, in the corresponding pictures, the structure height of the Phase 1 structure is substantially greater than ordinary high tide. Later photos show the structure height being set to the appropriate height, which is 1-foot above ordinary high water.

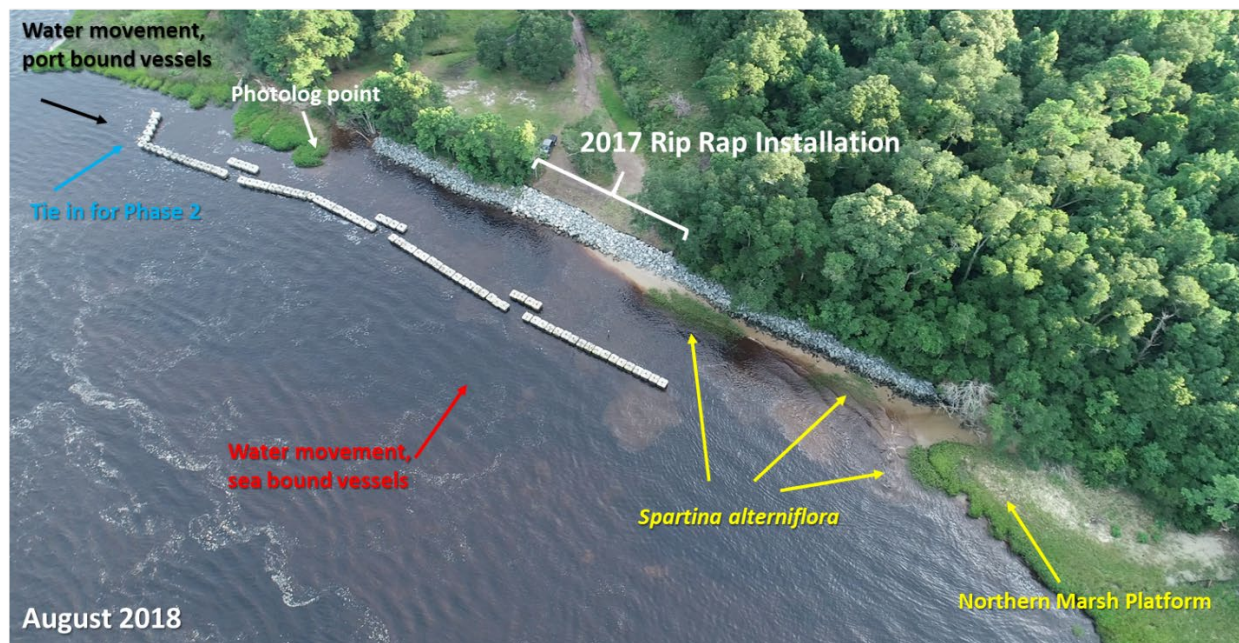
**Figure 9. Aerial perspective of BTFA (Phase 1 & 2) with notations of interest.**

The understanding of wave energy hitting the shore and Reefmaker structure from variable angles led to an alignment adjustment. Instead of having the terminal end continue to be parallel to the shoreline, the decision was made to have the structure’s terminal end at the south marsh platform be ‘flared’ back toward the shoreline. By flaring the structure toward the shoreline, the positioned Reefmaker would dissipate waves from port bound vessels and eliminate the wash of sediment upriver from behind the structure.

Phase 2 involved 240 feet of RM installation. Construction began in June 2018, and it was completed in late July 2018. During implementation, the extra ecodisks from the Phase 1 structure were moved and installed for the Phase 2 structure, being set at height of 1-foot above ordinary high water. The ecodisk trays at the lower end of Phase 2 structure were octagonal shaped. The alignment at the Phase 2 structure terminus involved constructing the structure to flare toward the shoreline to dissipate wave energy from port bound vessels (see Figure 9).

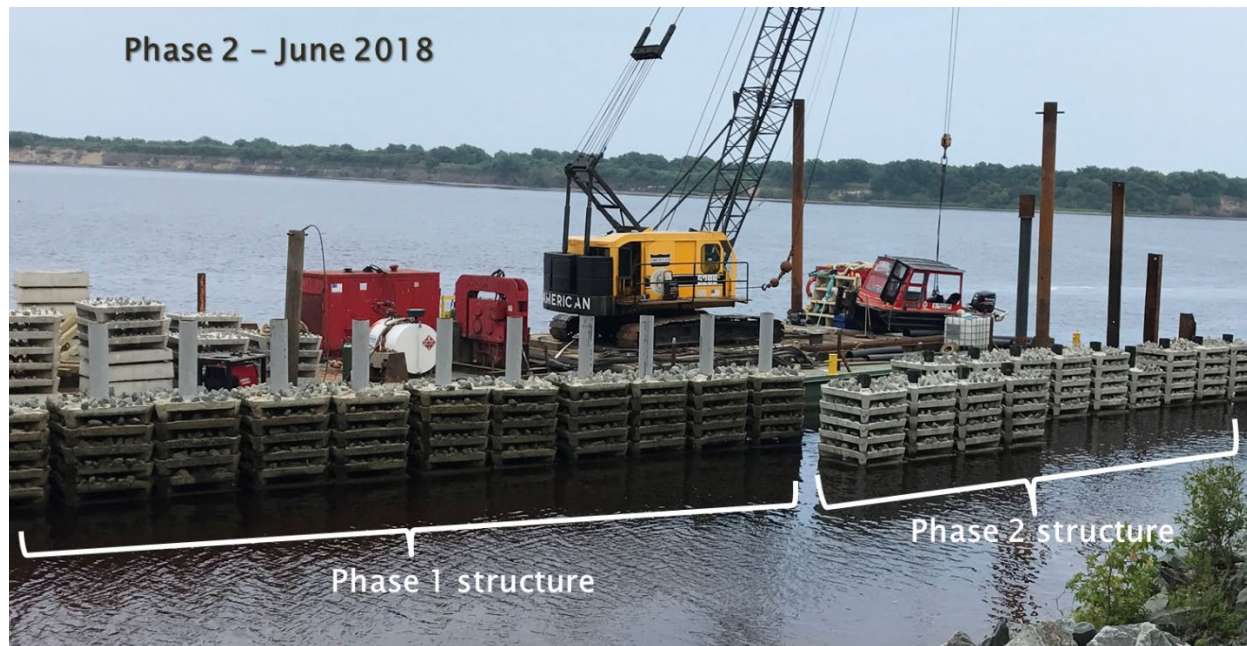
**Figure 10. Phase 2 installation with ecodisks from Phase 1 re-purposed for Phase 2**

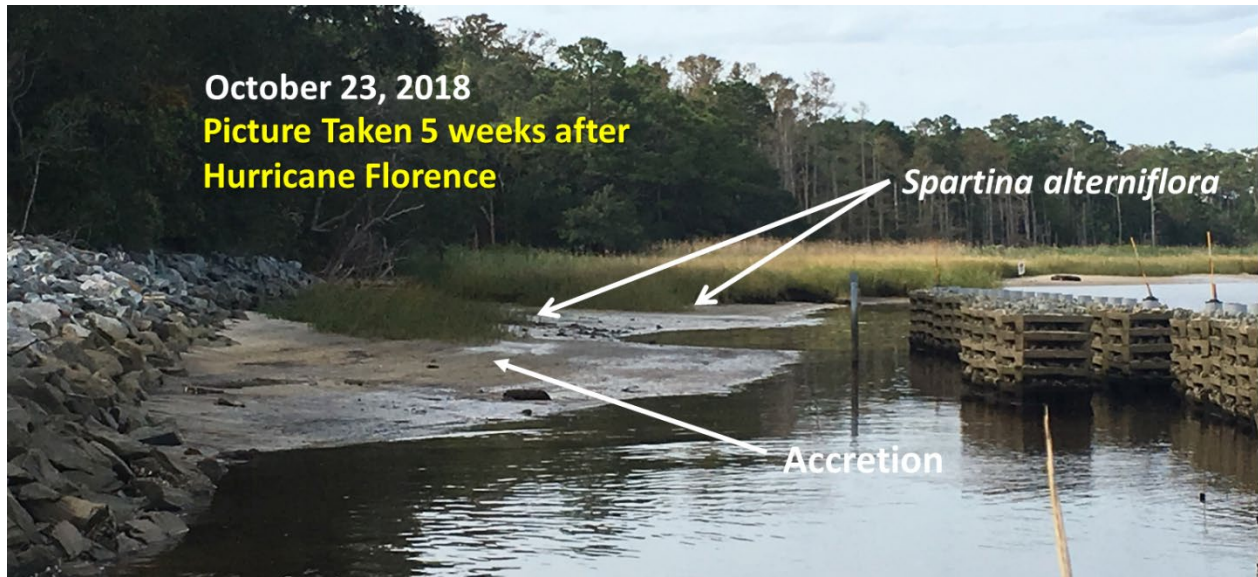
**Figure 11. Photograph of Phase 1 structure and accreted area**

The Reefmaker structure at BTFA has experienced several storm events. There were no significant storm events in 2017, but 2018 was a different story. The structure was tested as it withstood the several high tides with pounding storm surges and flooding associated with Hurricane Florence's landing in September 2018. The structure sustained no damage from the storm event, and the accreted sediments appeared to remain behind the structure even after the 3 weeks of flooding along the Cape Fear River.

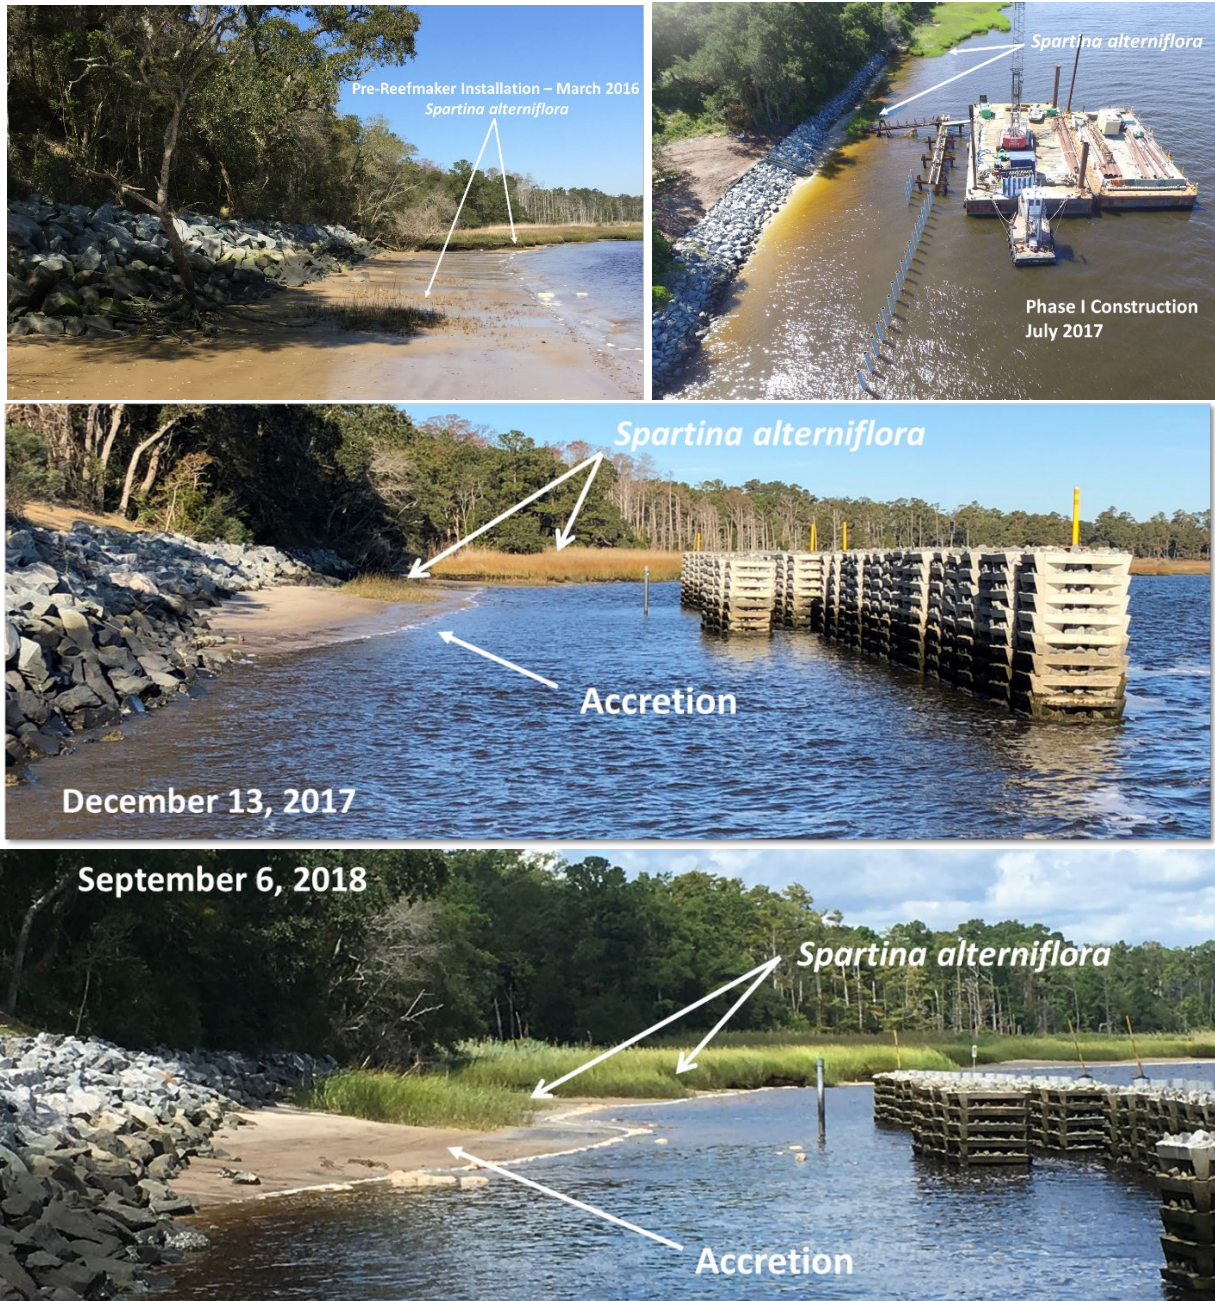
Figure 13. Photographs of *Spartina alterniflora* over time at the project site – March 2016 to September 2018.

Photographs of the project area also capture changes in *Spartina alterniflora* populations behind the structure.

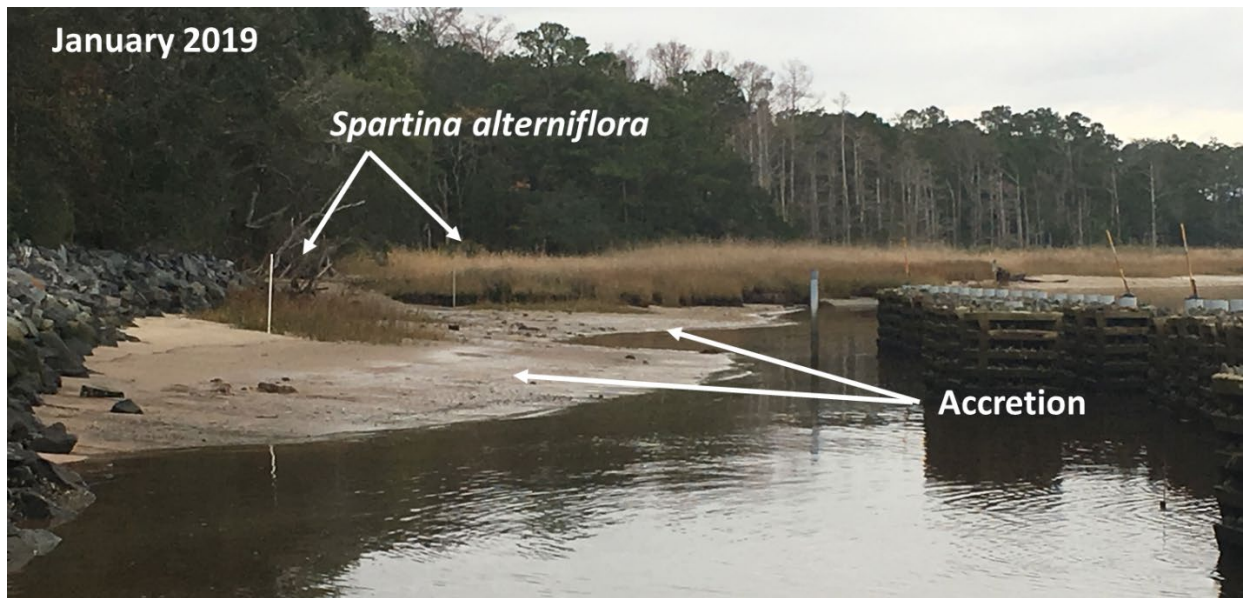
**Figure 14. Greater distribution of accretion behind Phase 1 structure.**

Since completion of Phase 2 (240 feet of Reefmaker with flank tie in) in late July 2018, there has been several noted changes regarding accretion. The sediment captured on the north end of the project, corresponding primarily to Phase 1, has become more distributed behind the structure.

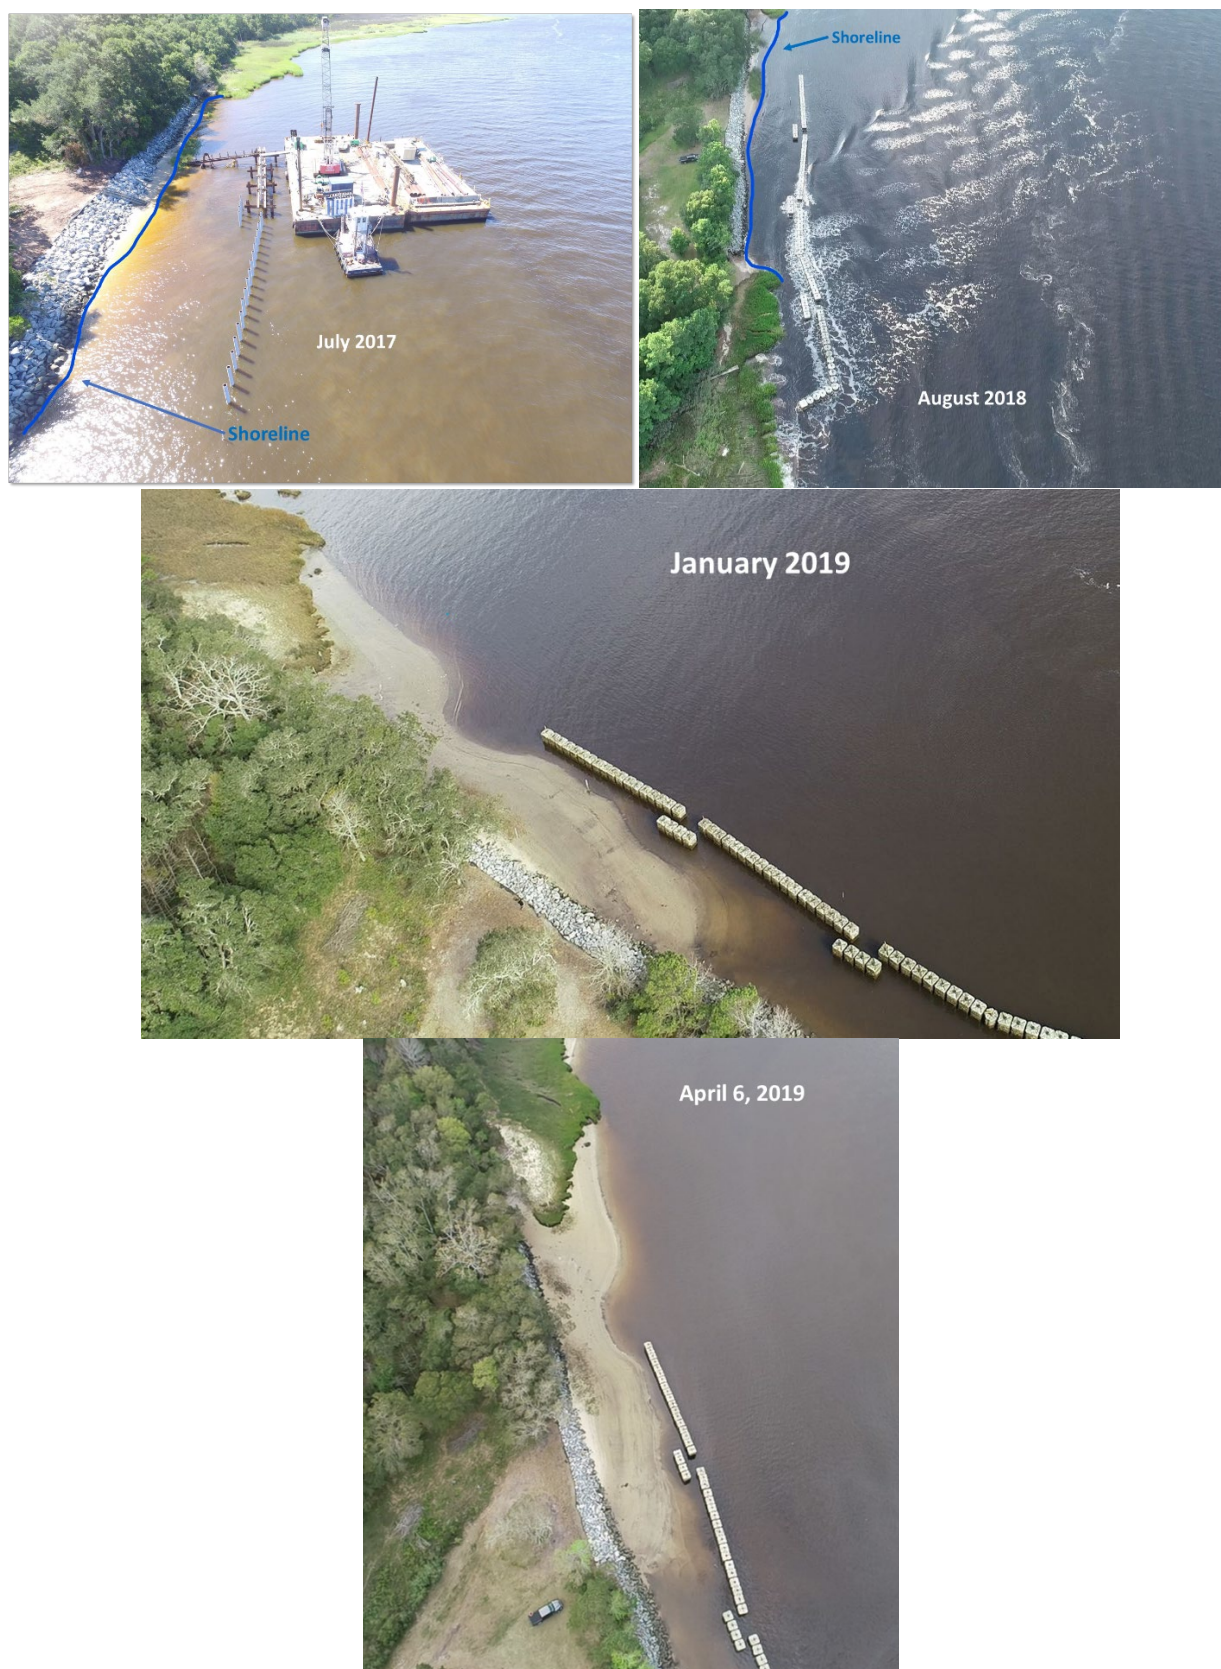
**Figure16. Shoreline change from July 2017 to April 2019.**

The following images note how the shoreline has changed at BTFA.

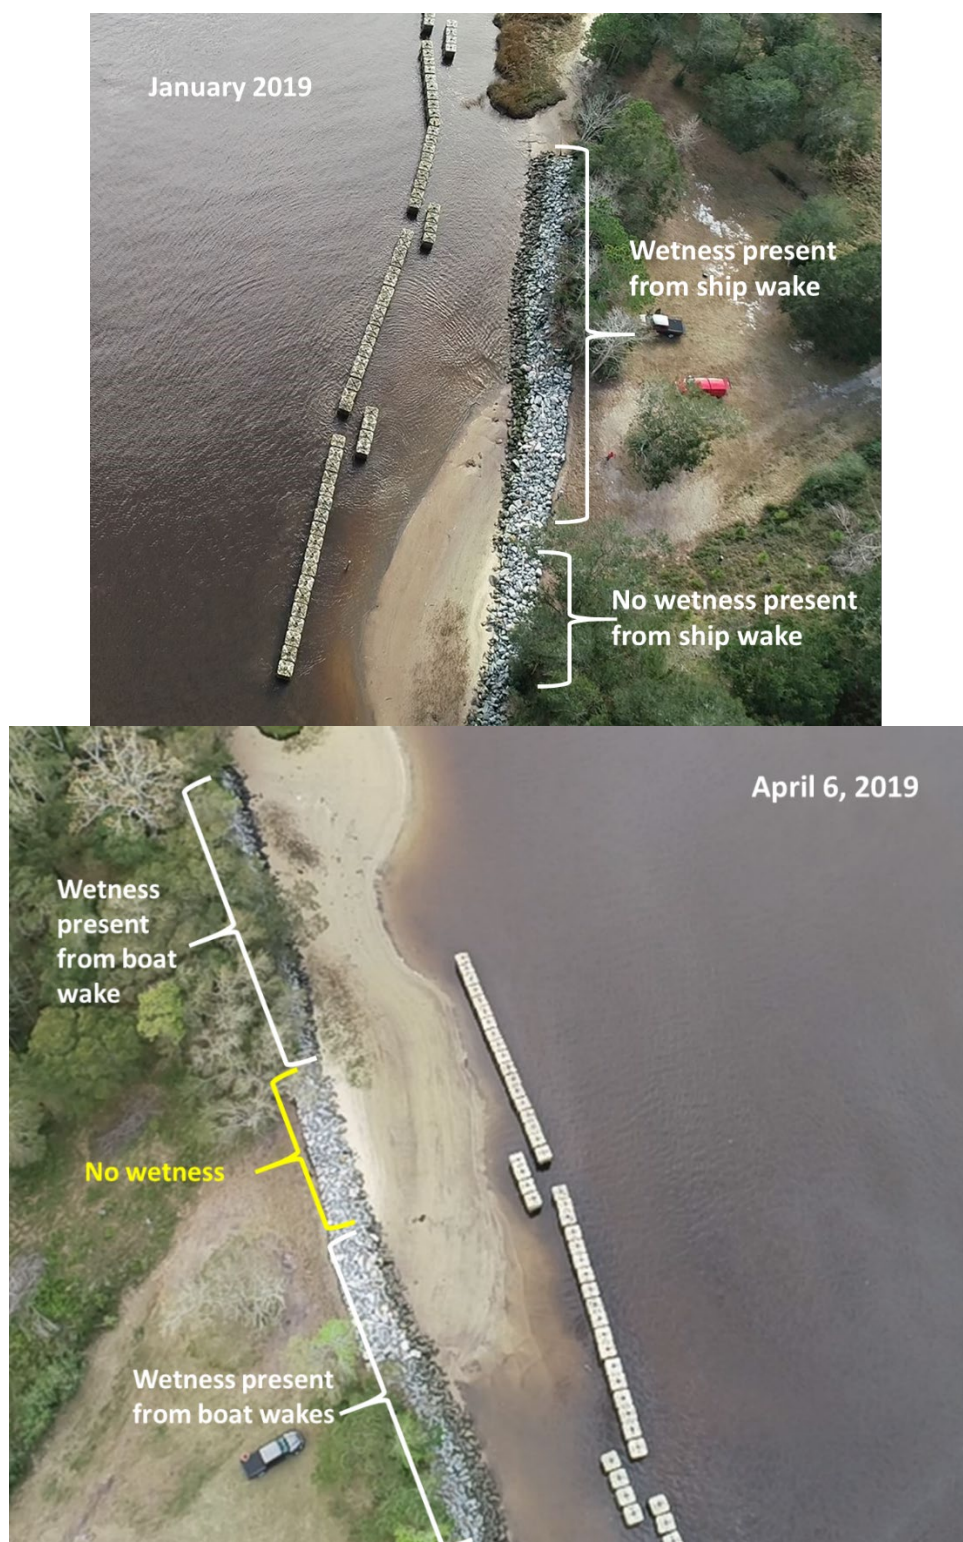
Figure 17. Presence/absence of wetness from ship wake

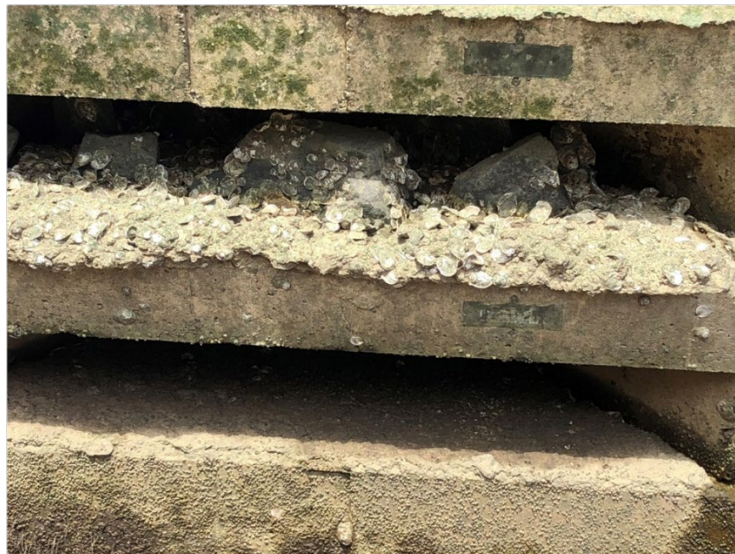
**Figure 19. Sessile fauna recruitment to the structure.**

Staff at BTFA have noted a greater number and abundance of marina fauna since installation of the Reefmaker structure. Structure has become a premier fishing spot on lower Cape Fear River attracting schools of striped mullet and creating ideal habitat for flounder, channel bass, striped bass, and blue crab populations.
